Alapocas Park Pedestrian Bridge (Bancroft Bridge) over Brandywine Creek Wilmington, Delaware

Bridge Alternatives Report

Submitted to:
Delaware Department of Natural Resources and Environmental Control (DNREC)

January 2022

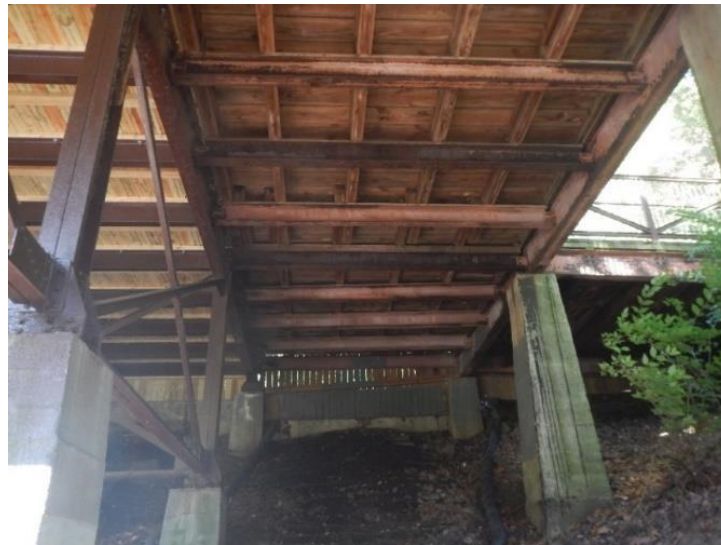
- Photo 5 – A series of short spans on the north side of the deck truss consisting of steel beams and timber decking and totaling approximately 75ft. The series of short spans are part of the flooring of the covered pavilion and are supported on concrete piers independent of the bridge piers.

Photos 5: Series of short spans on North side of the bridge

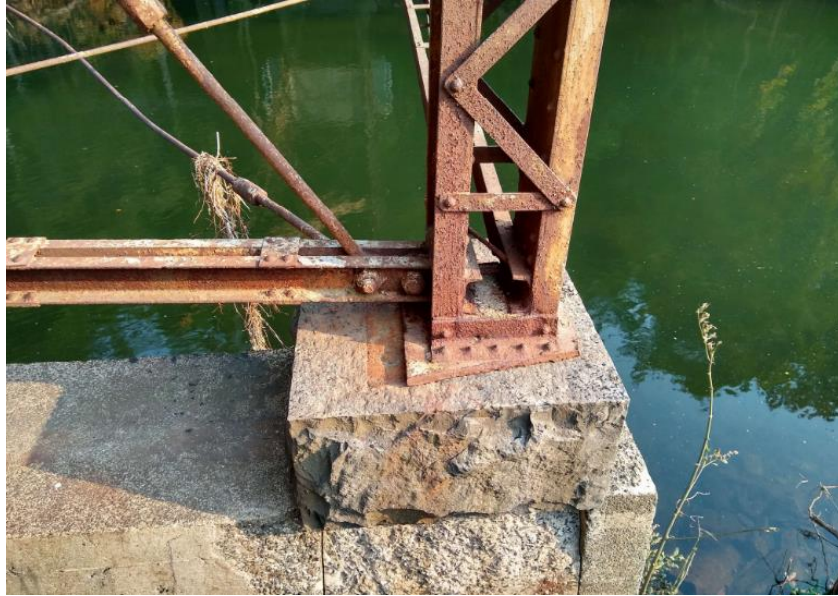
- Photo 6 – Pier 1 East post has sheared off at the anchor bolts and has moved by 4.5 inches
- Photo 7 – Pier 1 bottom horizontal is separated from the west post

Photo 6: Pier 1 East post sheared off at the anchor bolts and has moved 4.5 inches

- Replace any damaged truss members during horizontal jacking
- Repair the piers supporting the end posts of the deck truss bridge
- Replace all four end posts of the deck truss span and associated anchor bolts

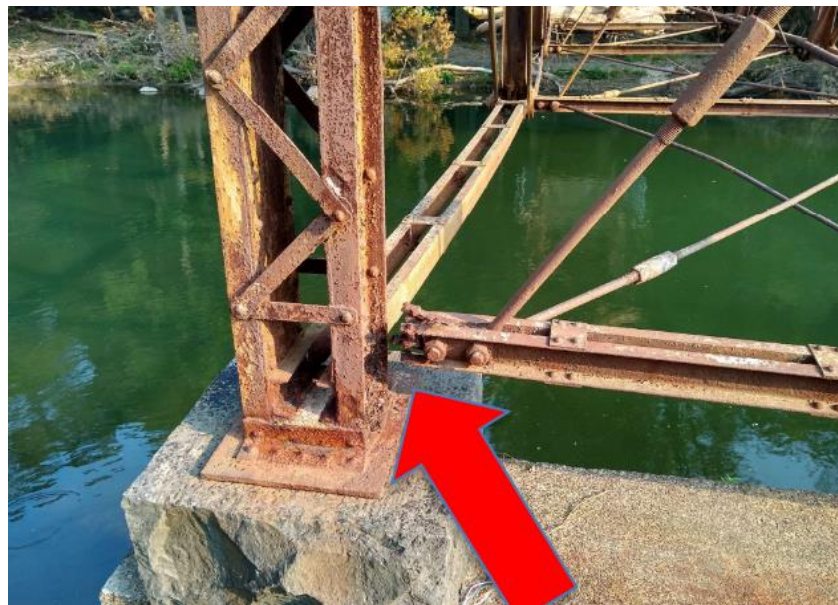
Photo 7: Pier 1 Bottom horizontal separated from west post

- Replace all bottom horizontal lateral bracings and connections
- Replace all vertical lateral bracings and connections
- Retrofit all members of the deck truss span as needed to upgrade the load capacity to meet current AASHTO standards

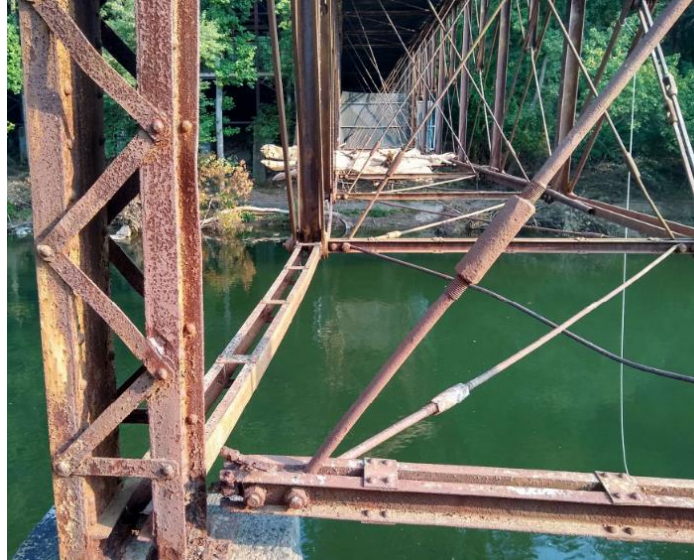
- Photo 8 – Bowing of the upstream and downstream trusses
- Photo 9 – Large tree limbs and debris stuck at bottom chord of the trusses with broken tie-rods
- Photo 10 – Pier 1 West post has shifted towards East

Photo 8: Bowing of the upstream and downstream trusses due to debris damage

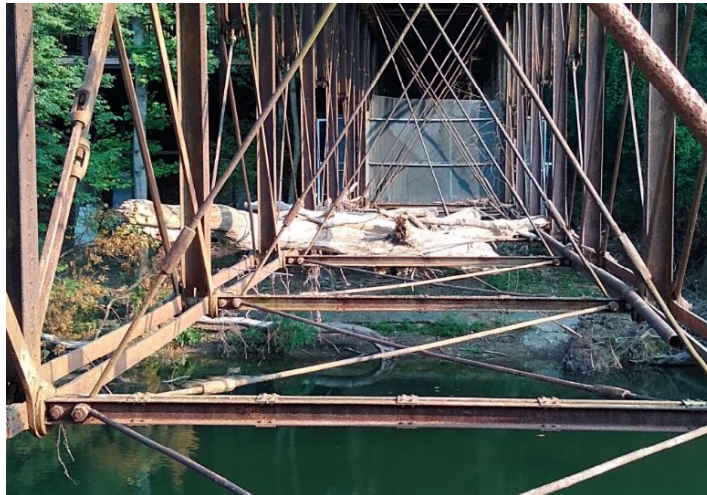
Photo 9: Large tree limbs and debris stuck at bottom chord of the deck trusses with broken tie-rods

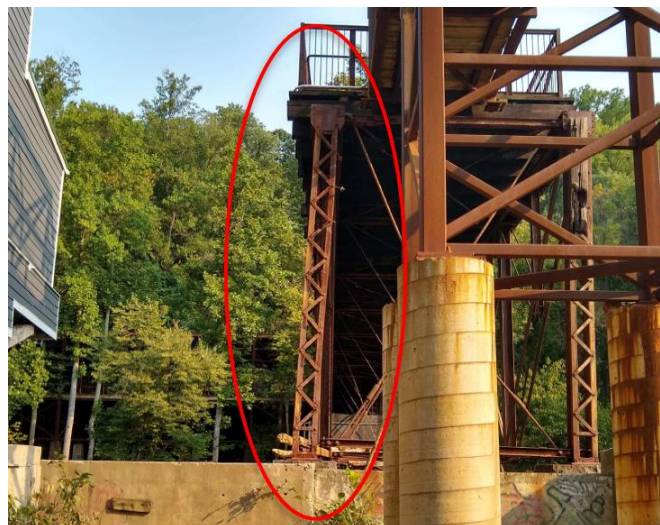
Photo 10: Pier 1 West post shifted towards East

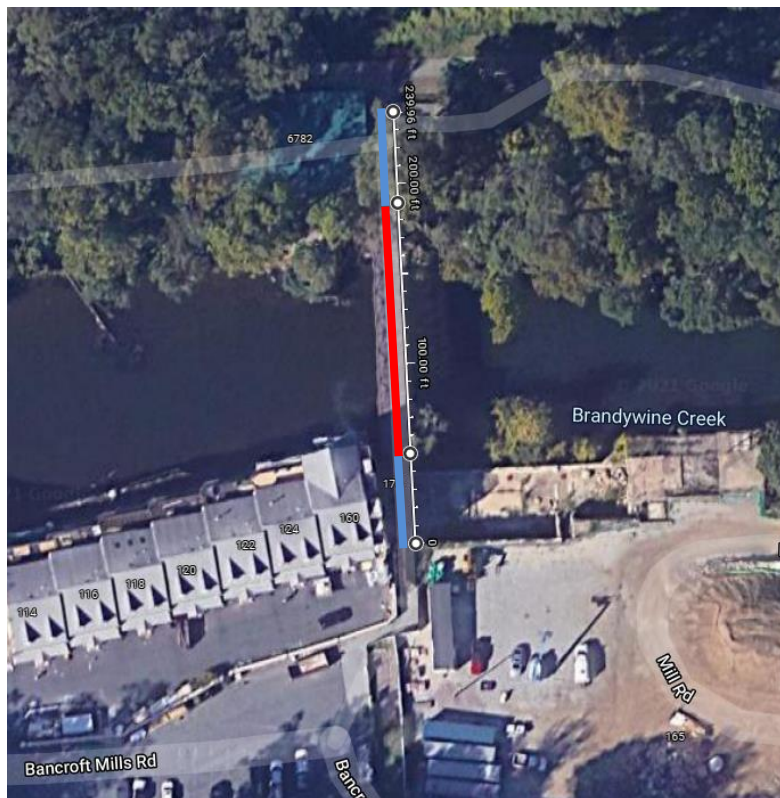
- Span arrangement – To understand the feasibility of fitting a new prefabricated pedestrian bridge span along the alignment of the existing bridge, a span arrangement of 50ft.-140ft.-50ft. was measured using google maps along the alignment as shown in Photo 19 as a blue-red-blue line. This distance was also confirmed through the data from the LiDAR survey. The three new simple spans will be supported on abutments and piers. Minor modifications to the pavilion floor system along the alignment, are necessary to isolate it from the new bridge. The seat elevations for the new spans can be adjusted to maintain the current deck elevation, and the new spans will be through Pratt trusses. This will raise the bottom of the new bridge above future flood elevation and will eliminate the susceptibility to debris related damage (see Photos 20 and 21 for comparison).

Photo 19: Simple span arrangement of 50ft.-140ft.-50ft. at the bridge site

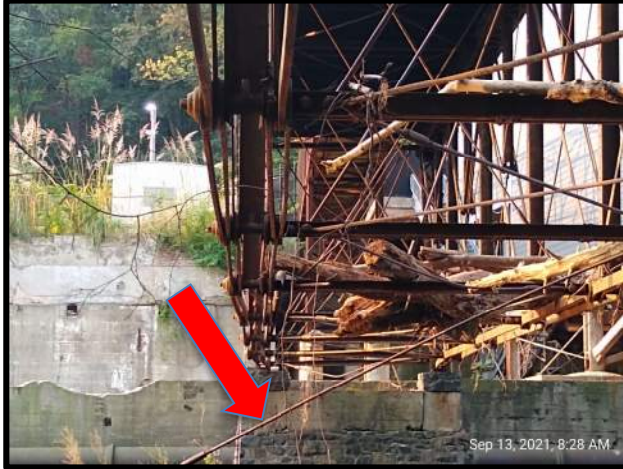
Figure 1:
Bottom diagonal tie-rod in fifth bay is broken on one end and hanging down.

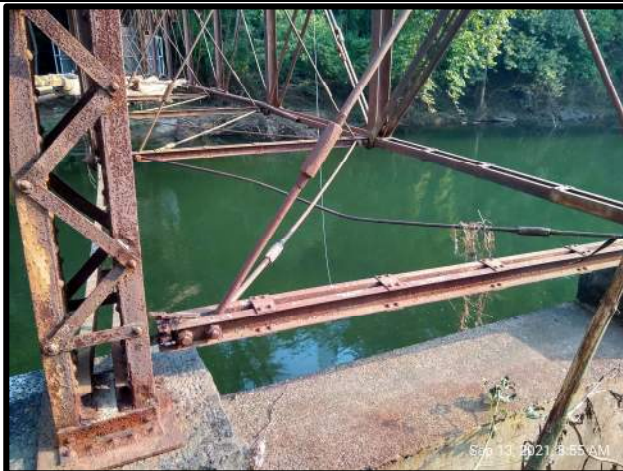
Figure 2:
Bottom diagonal tie-rod in first bay is severely bent from compression caused by the west truss shifting to the east.

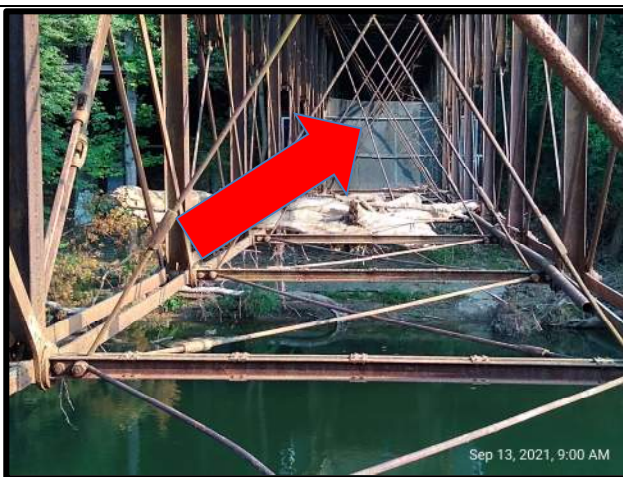
Figure 3:
Diagonal tie-rod in 4th bay connecting top west chord to bottom east chord is broken at the bottom and hanging from the top.

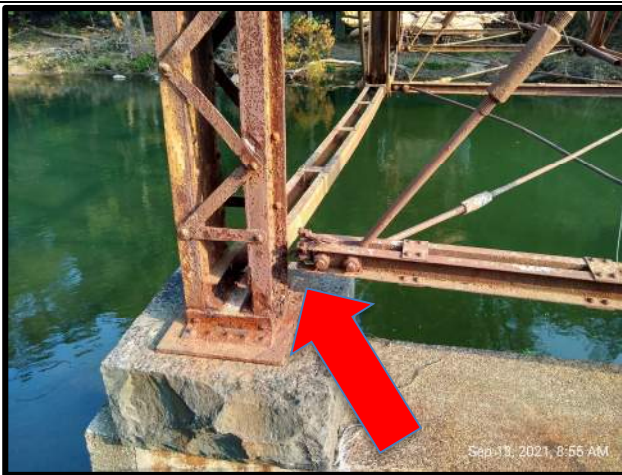
Figure 5:
Pier 1, bottom horizontal double channel is cracked and separated from the west post.

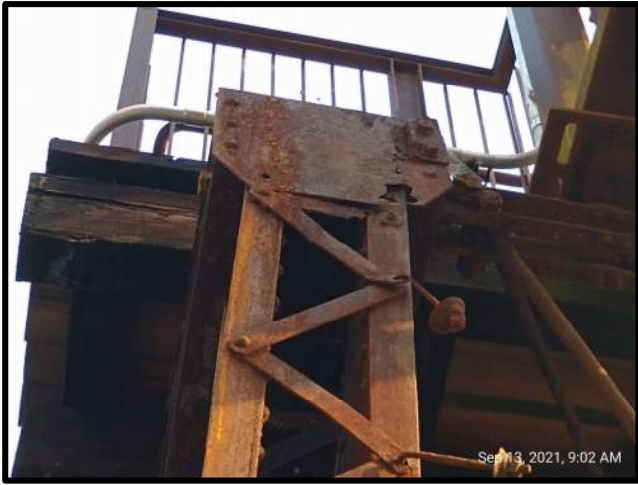
Figure 7:
Pier 1, west vertical post contains open crack at the top gusset plate. Diagonal lattice bracing is missing rivets in several locations.

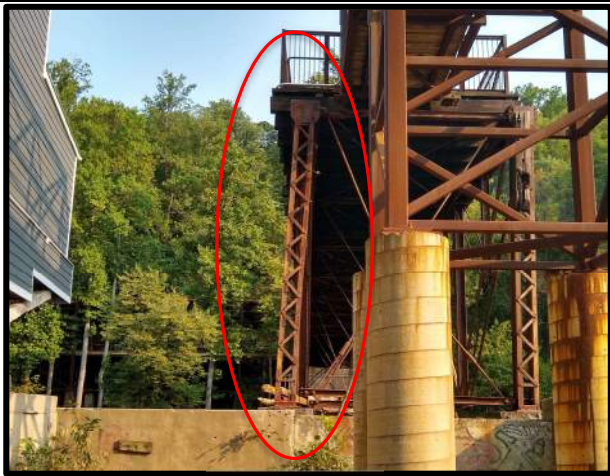
Figure 8:
Pier 1 west vertical post is leaning to the east.

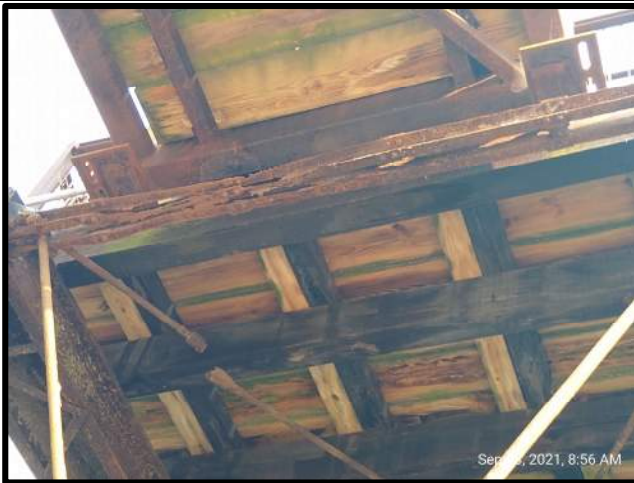
Figure 11:
The south end of Main Truss top
horizontal member is severely rusted
with extreme section loss. This element
provides no structural support.

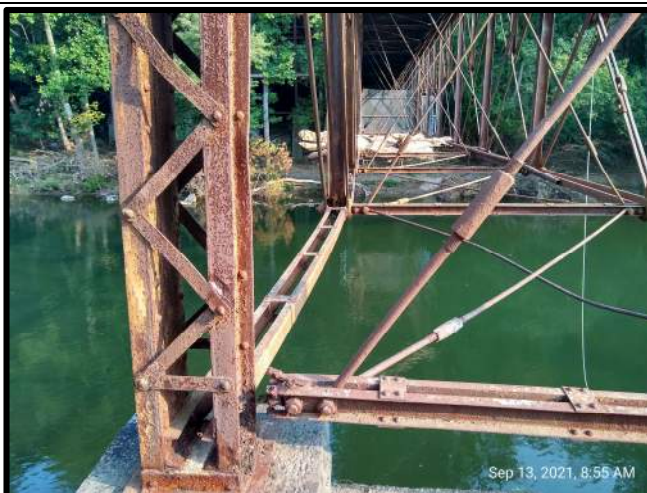
Figure 12:
The East and West Trusses are bowing
to the east. West Truss shown, West
Truss similar.

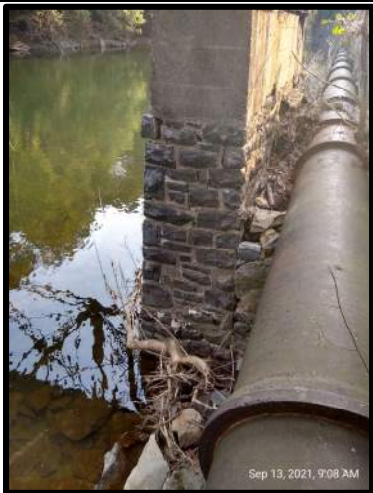
Figure 14:
Pier 1, stone masonry is dislodged on the north side of pier.

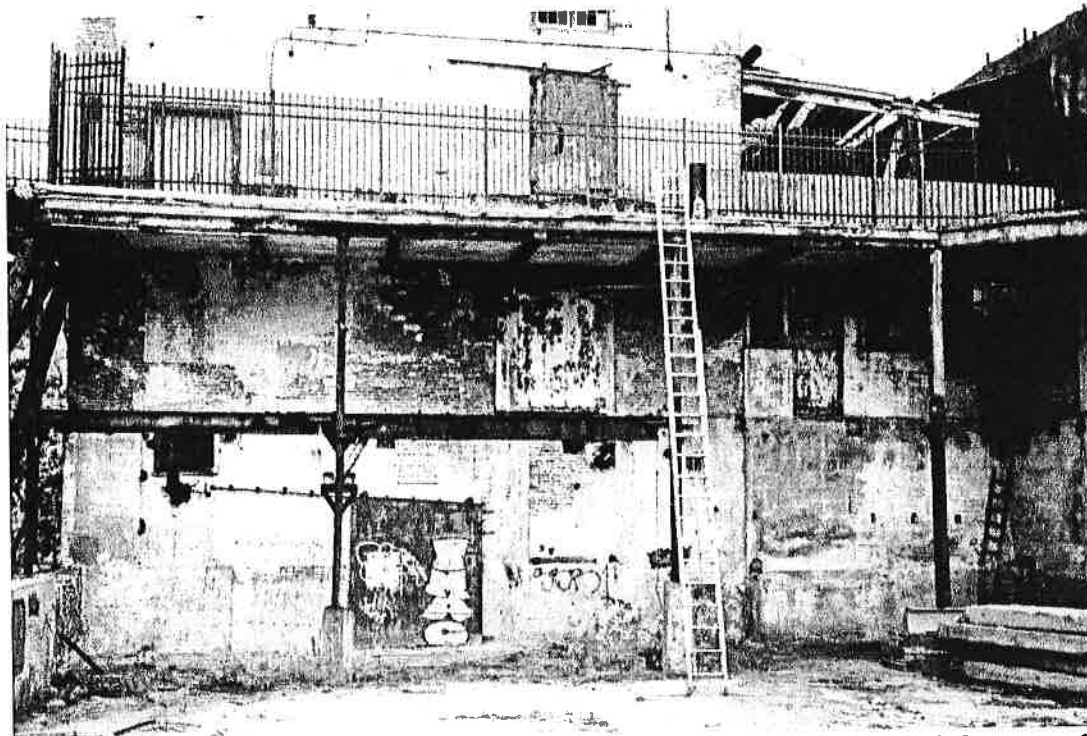
PHOTO #1-Elevation view of bridge approach showing corroded steel frame and existing mill building beyond.

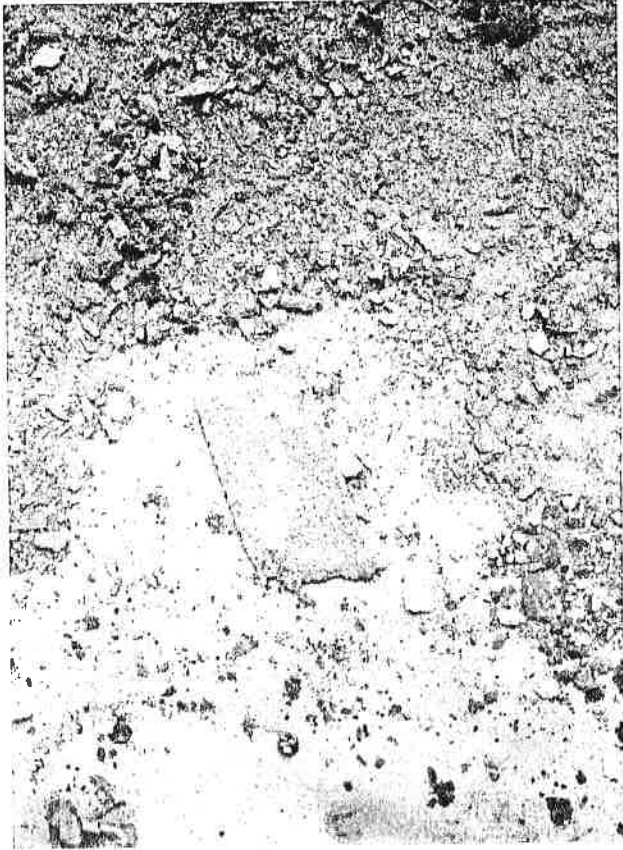
PHOTO #5-Portion of delaminated beam flange that has fallen from structure above.
